# Use of Chemical Oxidation Coupled with Bioaugmentation to Treat Groundwater Underneath a Day Care Facility

David Robinson, LSRP  
Ed Sullivan, PG, LSRP

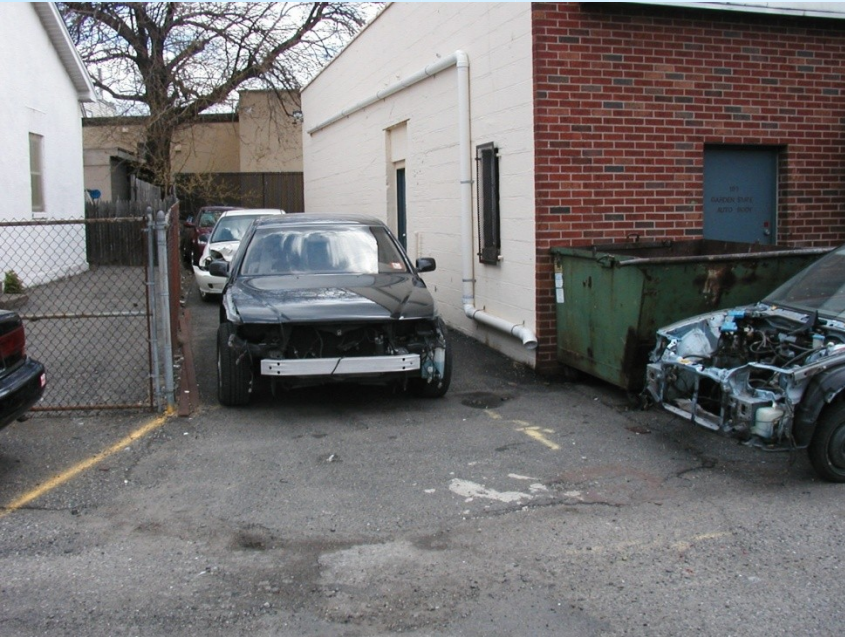
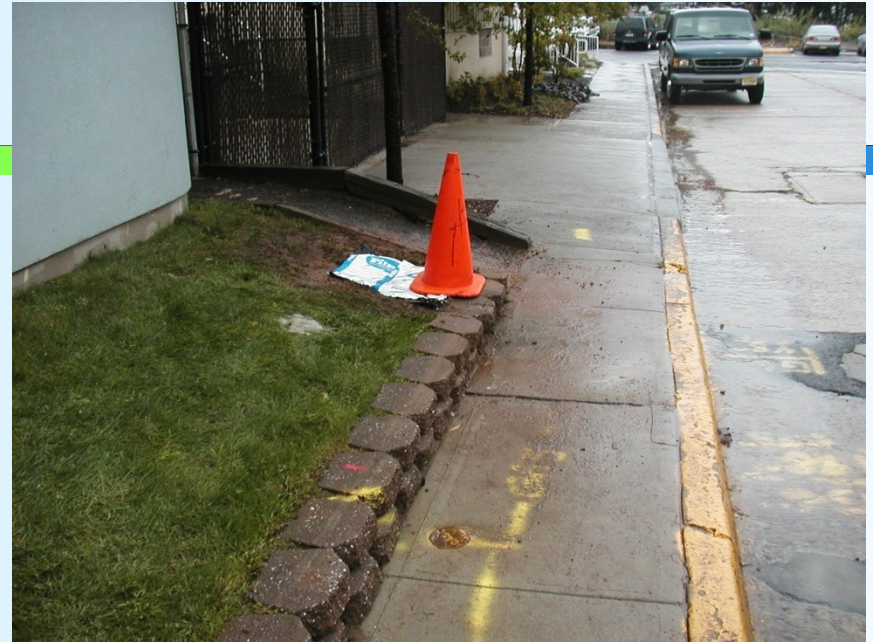
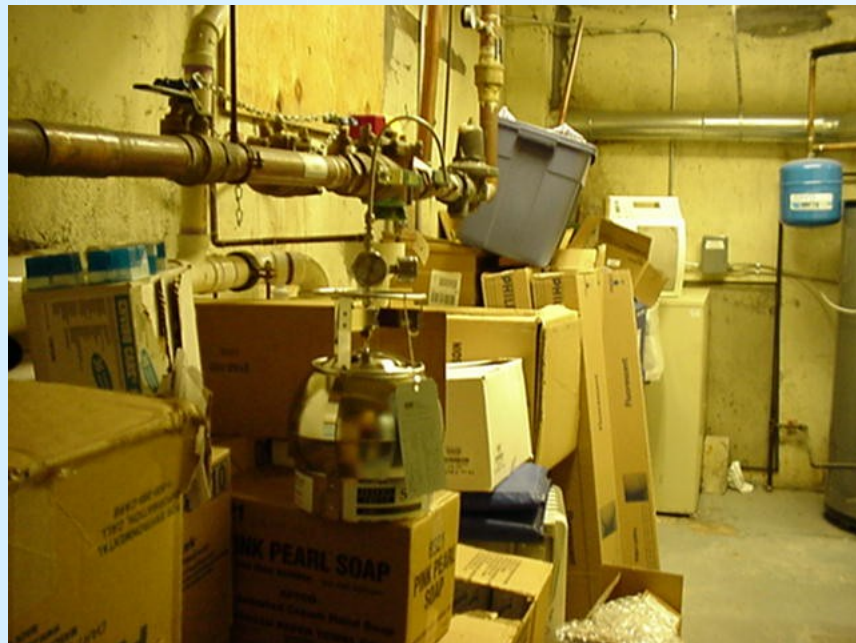
# Round 1 Injection Locations

- 12 injection points via GeoProbe
- Concentrated around tank/product areas
  - 4360 gallons 25% sodium persulfate solution
  - 7273 lbs persulfate
- Performed post injection monitoring 2 weeks and 6 weeks following injection
